## Leadframe Rework on ACTEL CQFP Packages

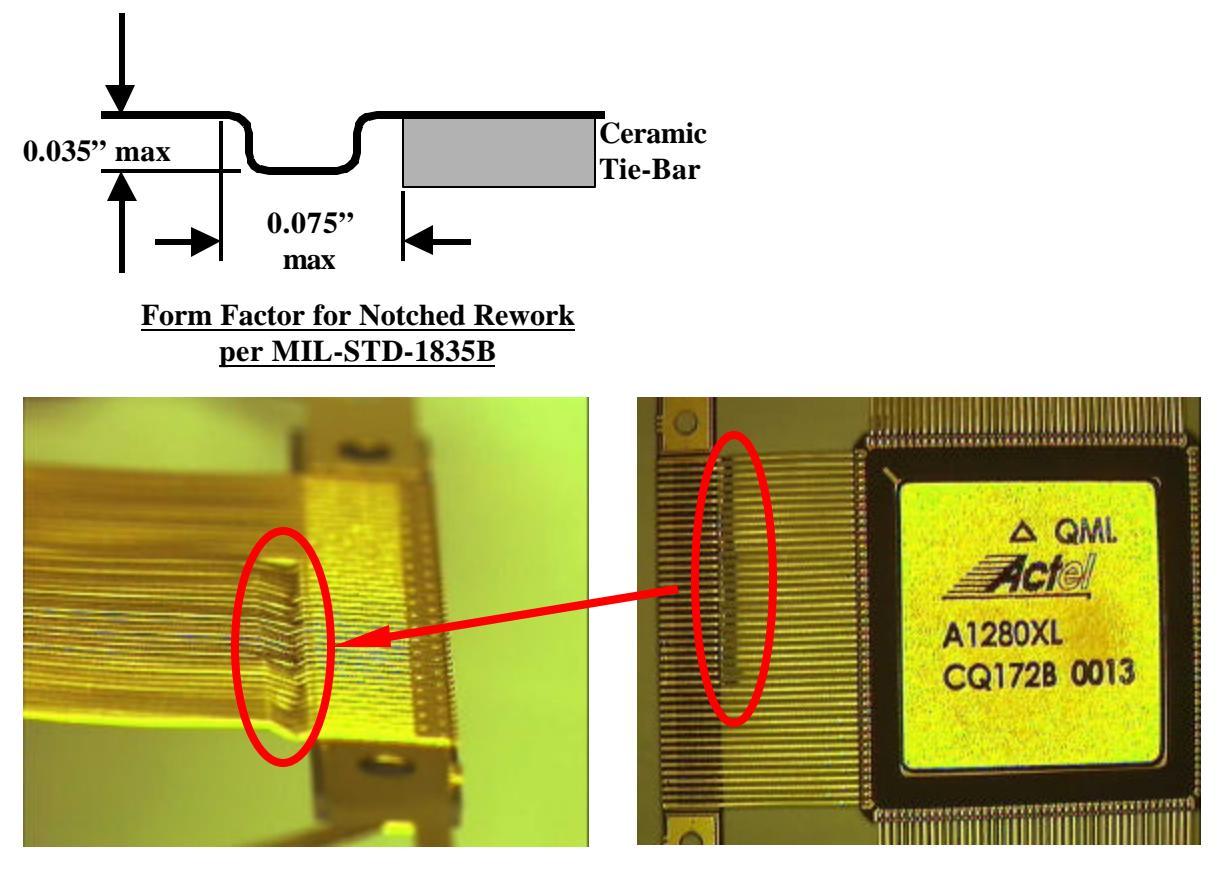
The following describes a notch that is put at the end of leads, near the ceramic leadframe during rework. <u>The standard leadframe rework is frequently mistaken as visual rejects like bent leads and scratches</u>.

CQFP packages have straight leads that are very thin and narrow in width, therefore, the leads are easy to bend during the manufacturing process. To effectively straighten the bent leads at final visual inspection, Actel implemented a procedure to mechanically put a notch at the end, near the ceramic leadframe (see picture). The form factor of this rework is clearly defined on MIL-STD-1835B, Notice 2, detail G on page 136 (see sketch), and note 11 on page 141.

Notched Lead Rework at the Edge of the Ceramic Leadframe

The reworked leadframe will not affect the device programming and testing performed at customer site, and the reworked area must be removed prior to lead forming process. Therefore, there shall be no concern on device form-fit factor, functionality, and reliability as the result of this rework.
